UPPER ARKANSAS RIVER COOPERATIVE NATURAL RESOURCE DAMAGE ASSESSMENT

Between: State & Federal Trustees, EPA and the Mining Companies

UPPER ARKANSAS RIVER BASIN (LEADVILLE, COLORADO)

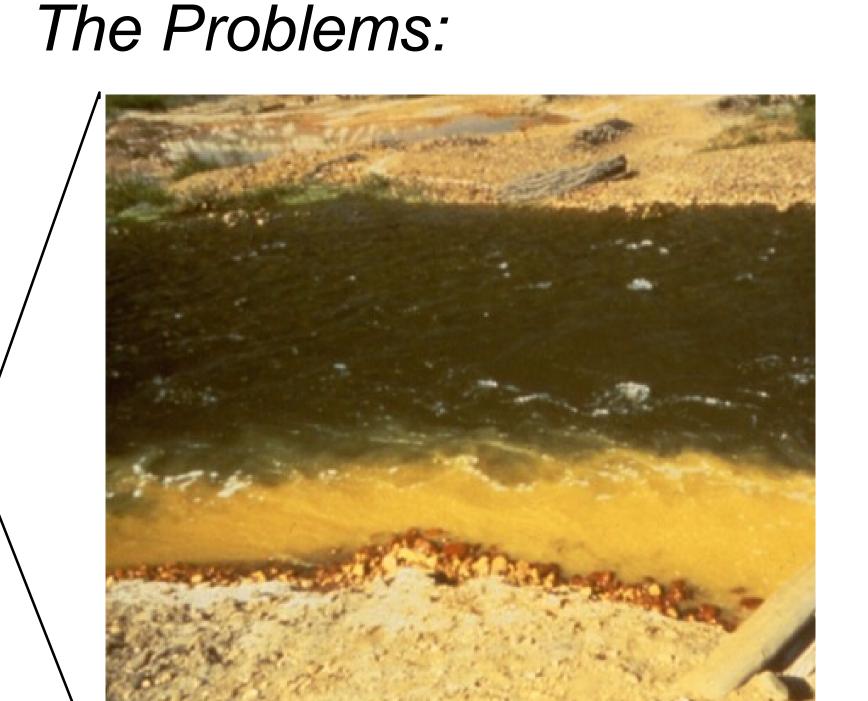
Mining Caused Acid Rock Drainage to Arkansas River

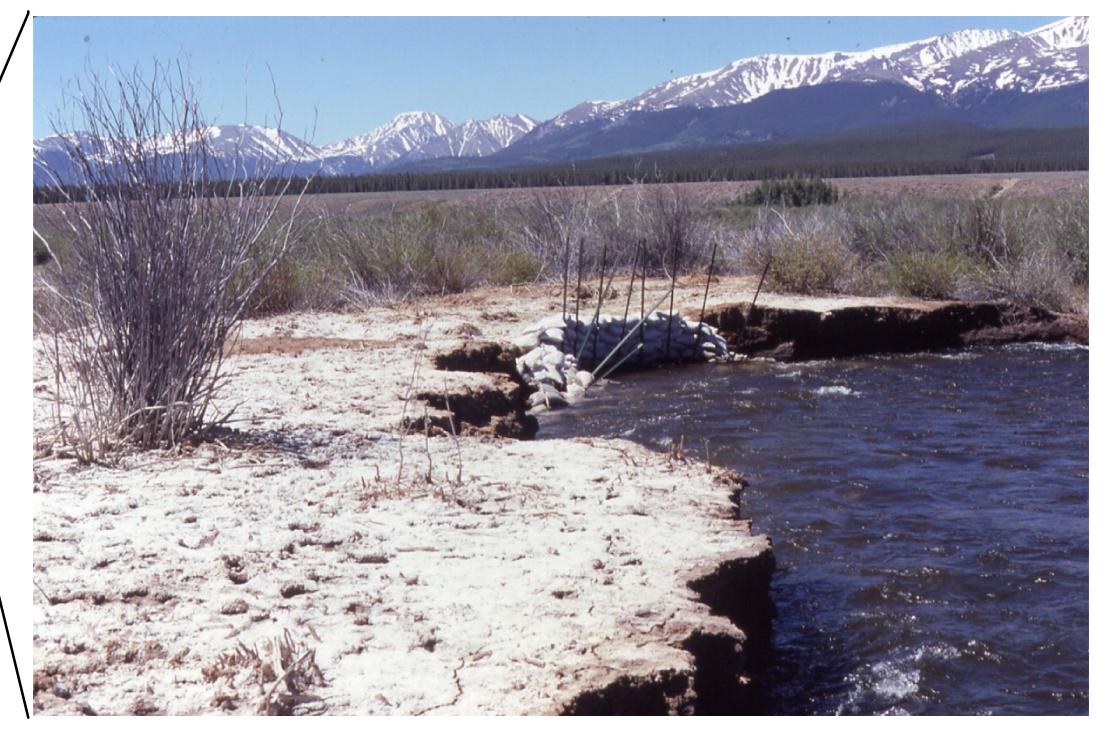
Fluvial Deposited Mine Waste Material

waste deposits occur (see fluvial	are observed during spring	A recently published report	There are no specific data for	11-iville Reacii.
mine-waste deposits).	runoff.	by Nehring & Policky 2002	Reach 1. Exposure would	
. Source of Injury: Available data		evaluated trends in trout populations over	occur primarily via the food chain and soils.	
does not indicate injury to		the last 16 years. This report	4. Extent of Injury: Existing data are	
vegetation growing on floodplain		indicates continued improvement in	for herbivorous small mammals. Insectivorous	
(riparian) soils. Source of injury is limited to		brown trout fishery. It states that if this trend	small mammals may be exposed to higher metal	
elevated metals in fluvial mine-		continues over the next several	concentrations, but they are also more	
waste deposits. Extent of Injury: Injury to		years, it may be strong empirical evidence that the	tolerant of metals exposure and injury is not

vegetation is limited to fluvial mine-waste		efforts at ameliorating heavy metal	expected to occur.	
deposits where vegetation cover		pollution are beginning to		
is less than 50%.		have a positive effect on the trout
